*JMS III, LLC*  
**TIRE ENGINEERING & TIRE FAILURE ANALYSIS**

**RE: GOODEN/CUBILLOS vs FEDEX, et al.**  
**JMS III FILE NO. 15-032**

An accident occurred when the left front tire failed on a 2011 Freightliner tractor pulling two trailers driven by Brian Kehler and the truck veered left across the center divider and collided with other vehicles.

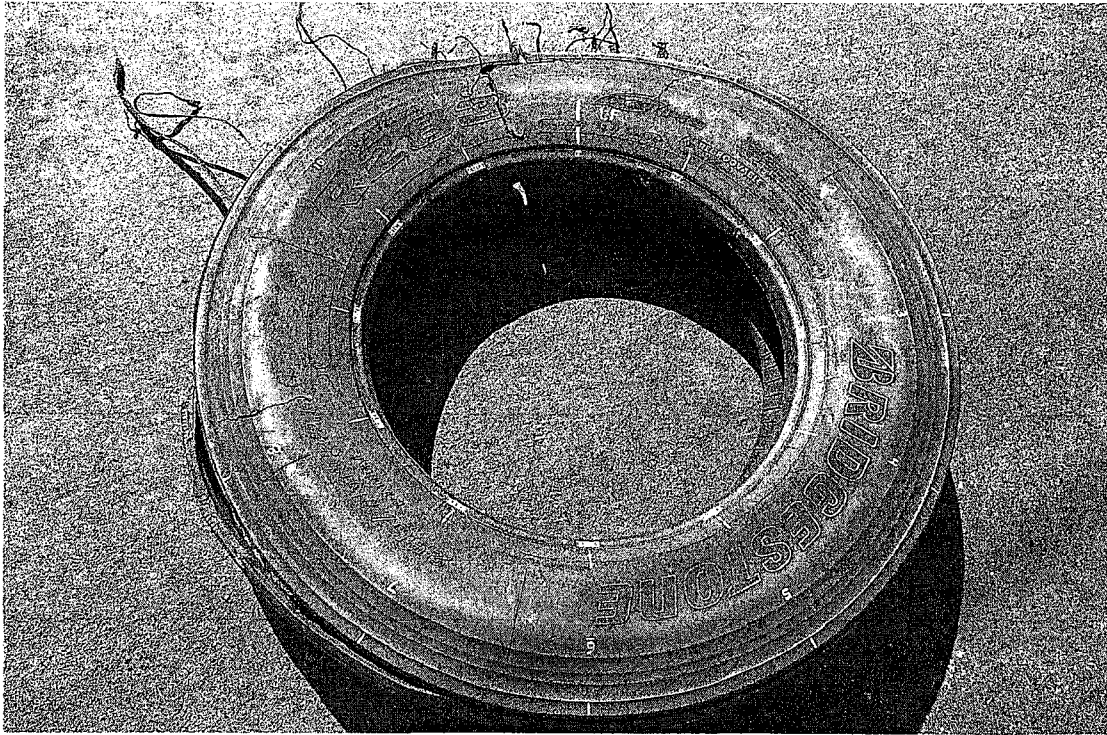
Figure 1 is a view of the serial sidewall of the tire casing and Figure 2 is a closer view of the serial side bead with a pattern that was transferred to the tire from the aluminum rim. The pattern reflects wear that occurred to the rim during the more than ½ million miles it was used with numerous various tires. Figure 3 is a view of the nonserial sidewall of the tire casing and Figure 4 is a closer view of the nonserial side bead with a somewhat different wear pattern transferred from the other side of the aluminum rim.

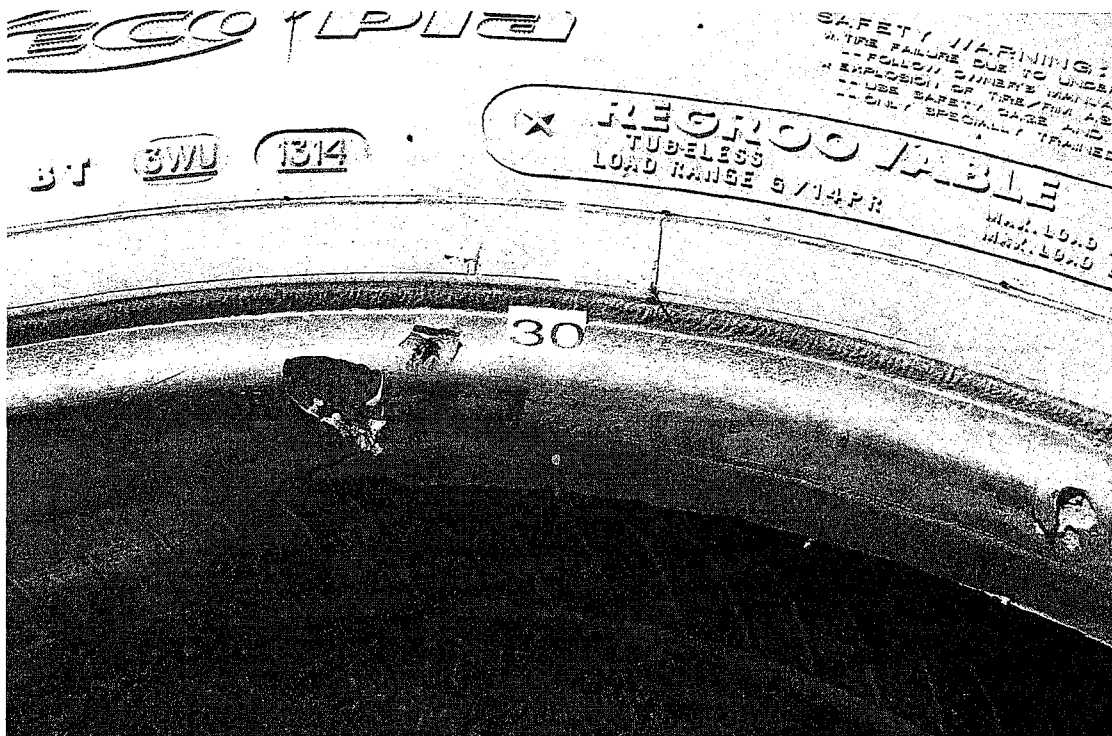
Figure 2

In their reports, Brian Queiser, Joseph Grant and John Smith identified rim compression grooves as evidence of underinflated operation. However, the marks on the tire beads, Figures 2 and 4, lacked any significant depth and were simply impressions of the worn, eroded surface of the alloy rim flanges, the result of wear that occurred during the more than ½ million miles the rim had been used. The squared edges of the tread shoulder ribs, Figures 8 and 10, and the overall even treadwear, Figure 9, along with the lack of sidewall scuffing, Figures 1 and 3, or innerliner abrasions, Figures 5 and 6, indicated that the tire was not run overdeflected.

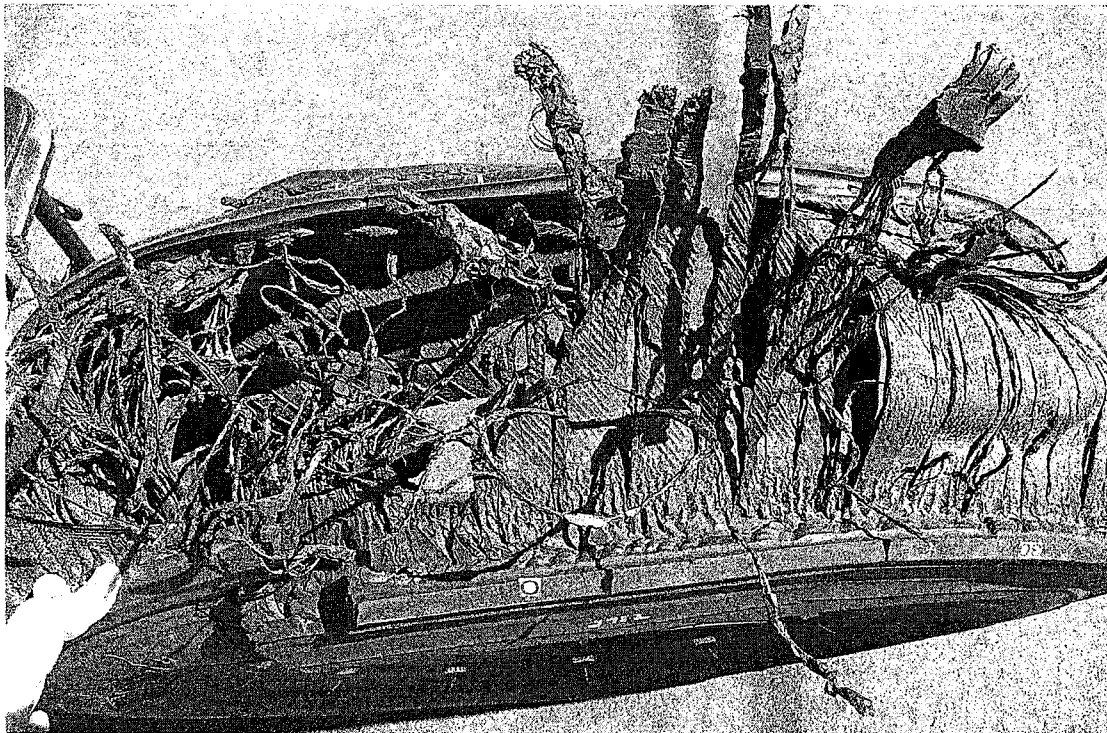
Figure 7 shows the area of the casing where the tread and all belts were missing and Figure 8 shows the square edge of the tread shoulder at that location. Figure 9 shows the area of the casing where the full tread was attached and Figure 10 shows the square edge of the tread shoulder at that location.

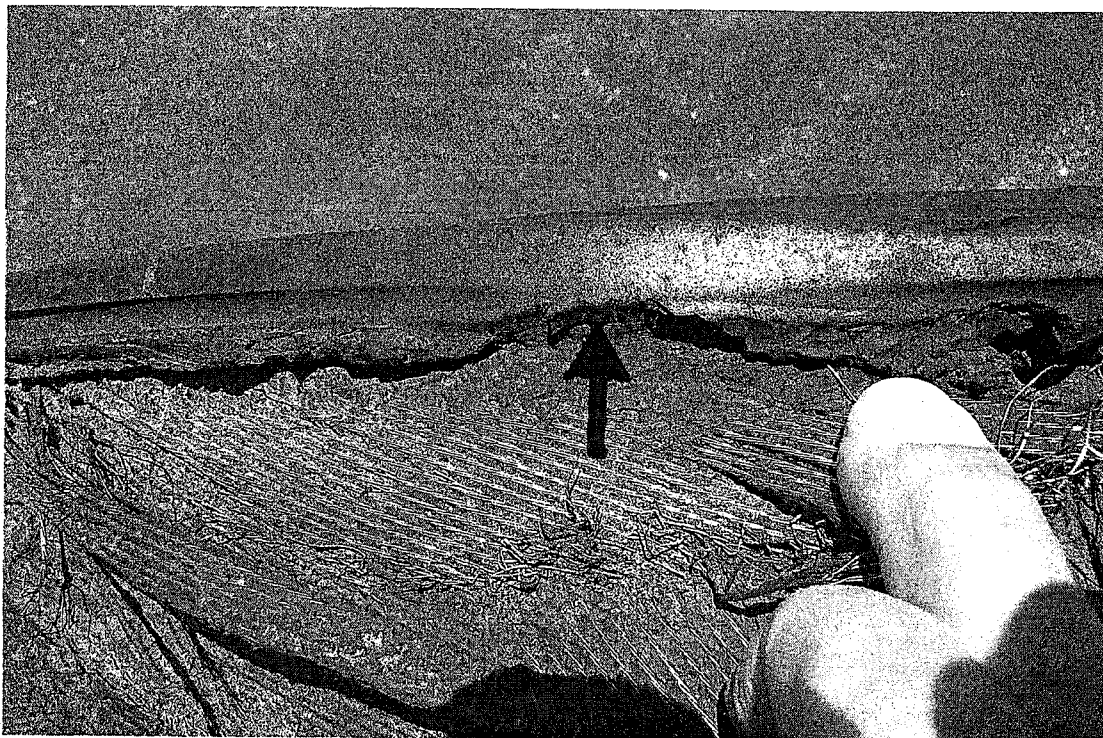
Figure 11 shows a localized area of the nonserial side tread shoulder where the outermost groove was worn completely away, indicated by the arrow near the center of the photograph. The groove can be seen on either side of the worn area, in Figure 11 and Figure 12, where it was approximately 6/32nds of an inch deep. Localized wear patterns such as this are caused when a long term internal separation, typically between the belts, allows the tread to squirm as it goes through the footprint; this squirming causes faster wear to the tread in the area above the separation. As the tire continues to be used, the separation will grow circumferentially and across the tread. Figure 13 shows polishing on top of the #2 belt where the separation extended to approximately 275 degrees on the nonserial shoulder. Figure 14 shows the underside of the separate tread piece where the separation between the #2 and #3 belts had expanded to within about 2 inches of the serial side shoulder and to about 30 degrees along the nonserial shoulder.
